# Corrosion-Induced Degradation of Marine Reinforced Concrete Structures: Case Studies from Polish Ports and Implemented Repair Methods

A. Wawrzyńska<sup>1</sup>, Tomasz Mioduszewski<sup>2</sup> & A. Maliszewska<sup>2</sup>

### 5.1 Case Study 1: North Breakwater, Port Gdynia

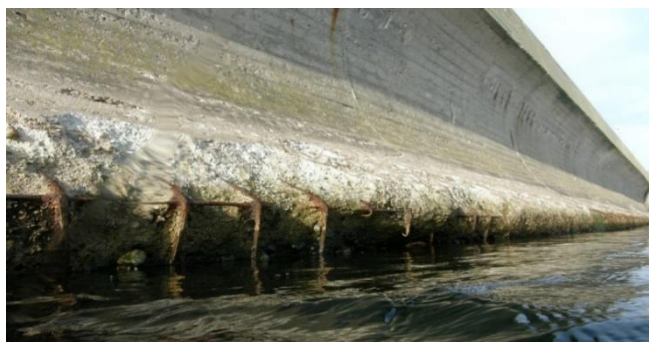
Underwater inspections carried out in the early 2010s revealed significant deterioration, especially on the seaward side. The timber palisade, topped with a reinforced concrete cap beam, showed advanced decay. Its porous configuration, combined with local material losses, led to migration of the stone backfill, decreased stability, and wave transmission into protected basins. Seepage through joints was also observed, causing water to emerge on the crest, (Fig. 1).

Corrosion was particularly severe along the tidal fluctuation zone, where the lower section of the cap beam exhibited spalling, deep losses, and exposed timber pile heads-signs of compromised structural integrity. Experts concluded that due to the extent of the degradation, partial demolition and comprehensive repair were necessary.

As a result, a full-scale rehabilitation of the seaward face of the head section was undertaken in 2012. The repair involved breaking down the damaged concrete parapet between +2.20 m and +0.70 m to a depth of 30 cm, followed by the installation of prefabricated reinforced concrete facing panels and the construction of a new parapet within this protective shell. The new parapet was cast from C30/37 concrete and reinforced with BS500S ribbed steel bars ( $\phi 12$  mm and  $\phi 16$  mm), with a specified concrete cover of 70 mm. The seaward wall was formed using prefabricated panels, while the port-facing side was coated with shotcrete made of C30/37 concrete, (Fig. 2, Fig. 3).

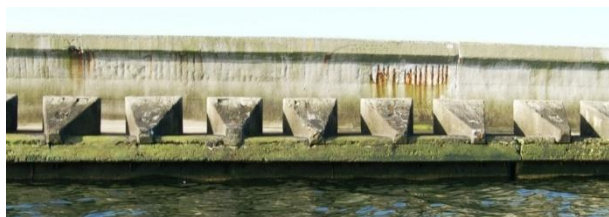
After more than forty years of continuous service, a condition survey conducted in 2015 identified significant deterioration, despite earlier localized repairs. The most critical issues included the poor state of the expansion chamber surface, exposed and corroded reinforcement in the parapet crest, cracked and unsealed joints between caisson units, structural gaps, and visible damage to the prefabricated deflectors mounted in the expansion zone. Out of the thirty such elements, many showed signs of advanced

Figure 4. Case study 2, View of the expansion chamber from the bay side: visible surface damage to the wave deflectors and exposed reinforcement of the breakwater parapet, source: own

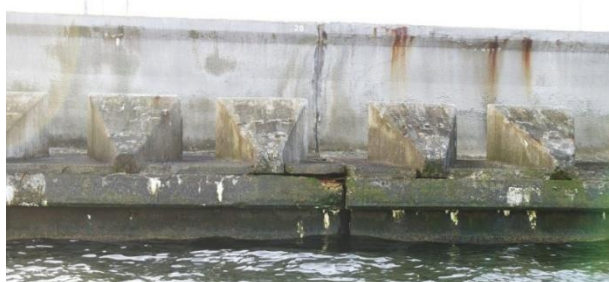
Figure 5. Case study 2, View of the expansion chamber from the bay side: visible damage to the superstructure (exposed reinforcement) and wave deflectors, as well as rust stains caused by reinforcement corrosion and concrete loss in the area of the structural expansion joints, source: own

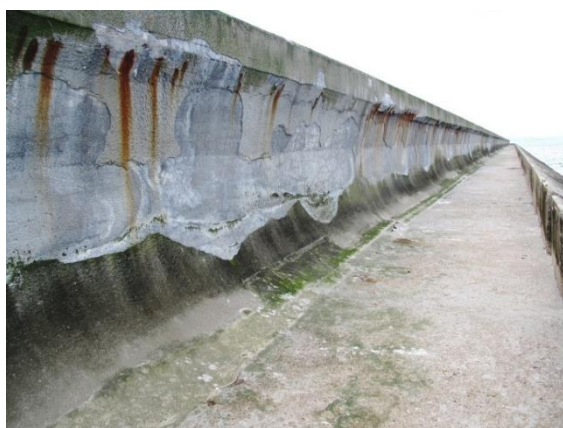
Figure 6. Case study 2, View from the expansion chamber; visible surface damage to the breakwater parapet following previously conducted repairs, source: own

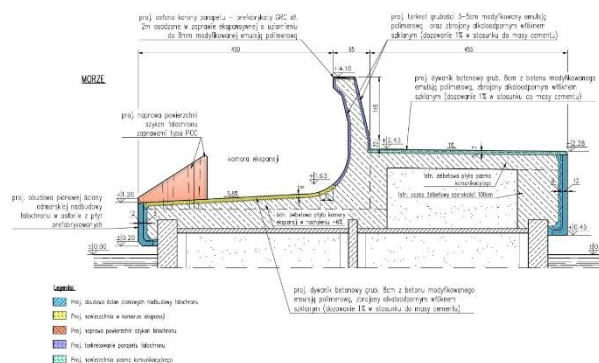
Figure 7. Case study 2, Typical cross-section of the Northern Island Breakwater within the scope of repair works [44]

Although the core function of the breakwater protecting the harbour remained intact, a comprehensive repair program was deemed necessary to preserve its operational performance. The remedial strategy involved the installation of prefabricated glass fiber reinforced concrete (GRC) components to shield the parapet crown, combined with polymer-modified shotcrete reinforced with alkali-resistant fibers to restore the surfaces. In areas adjacent to port infrastructure, the parapet was elevated to +4.90 meters above sea level, with new reinforced ribs introduced at regular intervals to support the additional height. The expansion chamber surface was rebuilt using an 8 cm thick overlay of polymer-modified concrete, also reinforced with fiberglass and treated with a hydrophobic sealant to enhance durability. Furthermore, both the seaward and port-facing cap beams were reinforced with cast-in-place concrete jackets, protected by precast facing panels (Fig. 7).

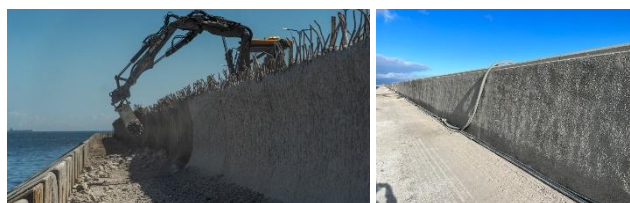
Figure 8. Case study 2, Left: Repair works on the seaward wall of the Northern Island Breakwater. Right: View of the repaired parapet of the Northern Island Breakwater from the inner side showing shotcrete coating on the parapet and surface sealing with spray applied polymer-cement coatings, source: own

The photograph (Fig. 8 left) shows the removal of the reinforced concrete parapet and the surface layer of the expansion chamber down to sound concrete, as well as the application of polymer-cement mortar. In contrast to the previously described repair works on another (Case 1) breakwater structure, this case allows for the evaluation of the superstructure repair only, as the intervention was completed just a few months ago (Figs. 8 right). Despite the short time since completion, initial signs of biological growth are already visible at the tidal fluctuation zone, indicating the beginning of natural environmental interaction with the renovated surface.

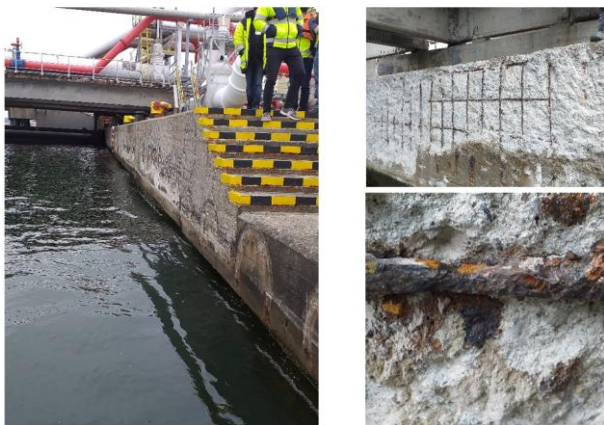
The quay, constructed in the 1970s, is based on prefabricated reinforced concrete caissons topped with a trapezoidal coping beam forming the superstructure. After over fifty years of service in harsh marine conditions, significant deterioration of the concrete surface was observed, particularly in the tidal zone. In several locations, reinforcement was exposed due to delamination of the concrete cover, leading to localized corrosion and structural concerns.

Figure 9. Case study 3, Condition of the quay and capping beam before the 2018 renovation, with close up views of the damaged elements shown on the right, source: own

To address these issues, a targeted repair program was implemented, focusing exclusively on the concrete elements of the superstructure (Fig. 9). The damaged concrete was carefully removed, reinforcement was cleaned and coated with a corrosion inhibiting primer, and reprofiling was performed using polymer-

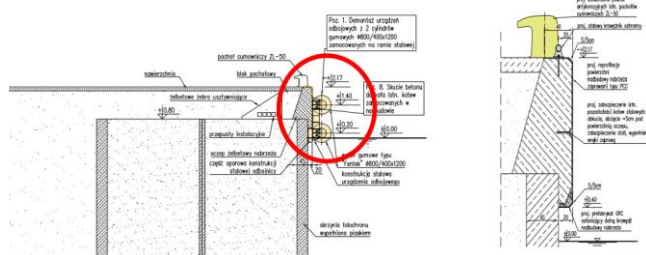
Figure 10. Case study 3, Fender line replacement project: close up view shows the designed surface reprofiling using PCC mortars and the proposed GRC prefabricated element protecting the lower edge of the quay superstructure. Platform modernization project: coloured elements indicate components designated for repair; a detailed view is shown on the right [45]

modified PCC mortars classified as R4 according to EN 1504. To protect the lower edge of the coping beam from ice abrasion, L-shaped GRC prefabricated elements were installed along the quay wall-20×20 cm in standard areas and 20×80 cm at the low quay section recesses where access ladders were located. The selected materials ensured resistance to chlorides, seawater, frost cycles, and mechanical impact. Final surface finishing included sealing with flexible polymer-cement coatings and injecting PCC mortar between the GRC panels and the original concrete to create a durable, cohesive repair system suitable for long-term exposure in a marine environment (Fig. 10, 11).

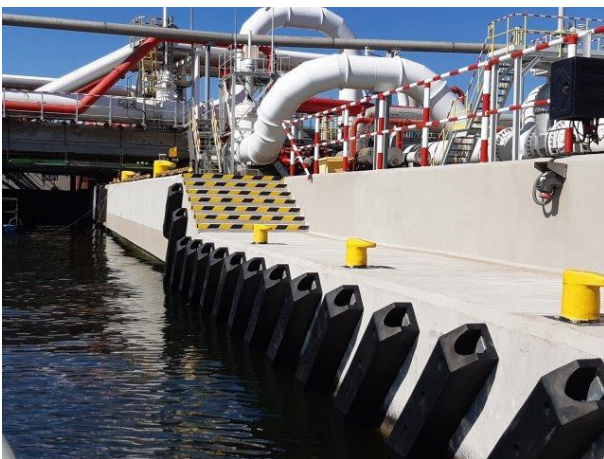
Figure 11. Case study 3, View of the modernized structure after reconstruction, source: own

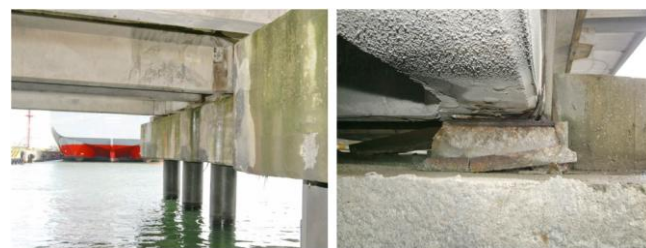
Case 4 concerns the renovation of a reinforced concrete access platform and approach walkway leading to a port berth, originally constructed in the 1980s. The structures, consisting of precast prestressed beams supported by reinforced concrete pile caps on prefabricated piles, had been in continuous use for over thirty years under severe marine conditions. Prolonged exposure to saltwater, temperature changes, and heavy use led to advanced degradation of concrete, reinforcement corrosion, and damage to the steel bearings supporting the spans (Fig. 12).

Figure 12. Case study 4, Condition of the platform before renovation. Visible severe damage to both fixed and unidirectional sliding bearings. Extensive corrosion is observed on both steel and elastomeric components. Bearing pedestals are heavily degraded, with numerous cracks, material losses, and spalling, source: own

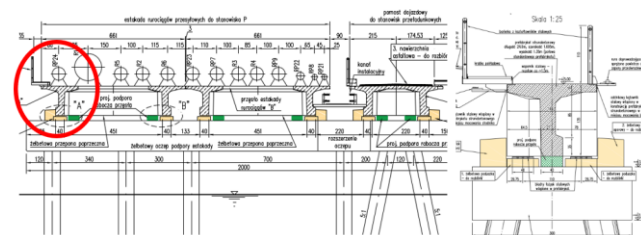
Figure 13. Case study 4, Platform modernization project, with the elements designated for renovation marked in colour; a structural detail is visible on the right side [46]

Based on a prior technical assessment, a comprehensive repair project was developed. The scope of work included reprofiling and waterproofing of the top and side surfaces of the pile caps, patching and sealing cracks and defects in the precast beams, replacement of corroded steel bearings with elastomeric types, application of anticorrosion coatings to steel components, and the installation of protective surface systems on areas vulnerable to moisture and environmental exposure. The project employed a variety of advanced materials, including PCC repair mortars, dry spray shotcrete, epoxy-based compounds, low-shrinkage and expansive grouts, and flexible protective coatings. Waterproof PVC membrane expansion joints were also installed to ensure tightness and structural durability (Fig. 13).

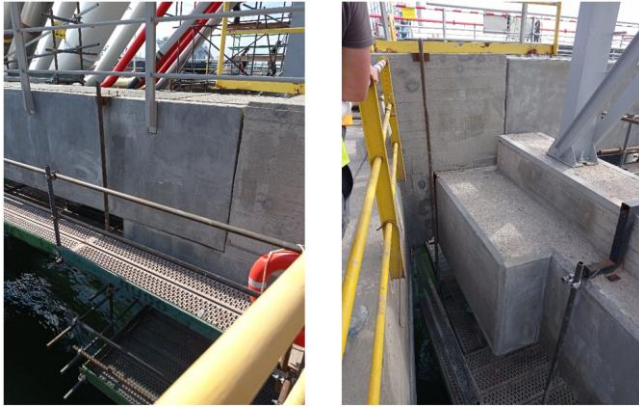
Figure 14. Case study 4, Condition of the platform after renovation, source: own

Work was conducted in phases using suspended scaffolding and temporary supports, allowing parts of the installation to remain in service during the renovation. The adopted technologies and material solutions restored the structural integrity and serviceability of the platform, extending its operational life for decades to come (Fig. 14).

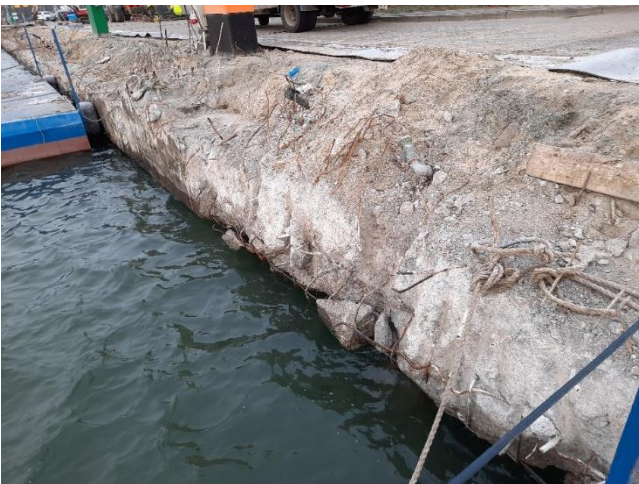
Figure 15. Case study 5, Quay condition before renovation, showing significant concrete losses and exposed, corroded reinforcement wall, source: own

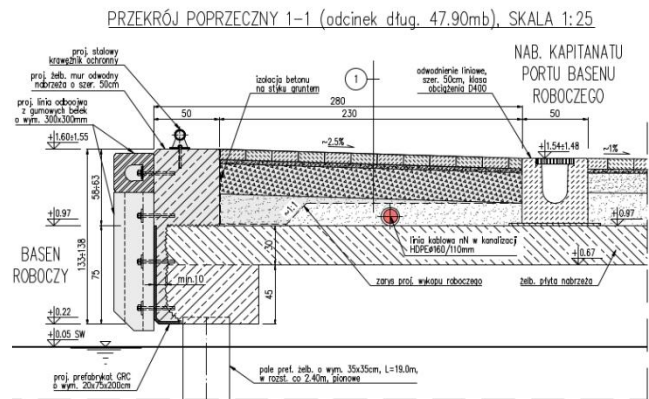
Figure 16. Case study 5, Project for the renovation of the mooring and fender line, including the proposed GRC prefabricated element [47]

The project concerned the renovation of a section of a berthing quay constructed in 1974, used primarily for tug operations. The objective was to replace the obsolete fender line and refurbish the mooring walkway to meet current operational requirements. The jetty type structure, supported on three rows of prefabricated reinforced concrete piles, included a rear steel sheet pile wall anchored with rock fill (Fig. 15). The scope of works included dismantling of existing fender units and walkway components, construction of a new reinforced concrete coping wall, and installation of point type fender systems using rubber beams with steel stiffeners. The outer edge of the walkway was protected with L-shaped GRC prefabricated elements, and the paved surface was designed in compliance with maritime construction regulations. Mooring bollard blocks were replaced, and coping wall extensions were added at fender locations. The work was divided into three stages to maintain berthing capacity for four tugs throughout the rehabilitation (Fig. 16, 17).

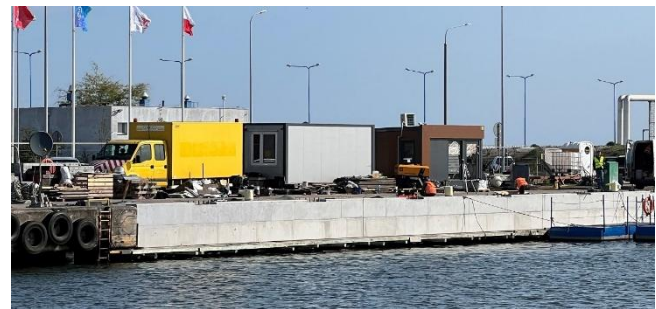
Figure 17. Case study 5, View of the mooring and fender line after reconstruction, with the GRC prefabricated element visible on the quay wall, source: own

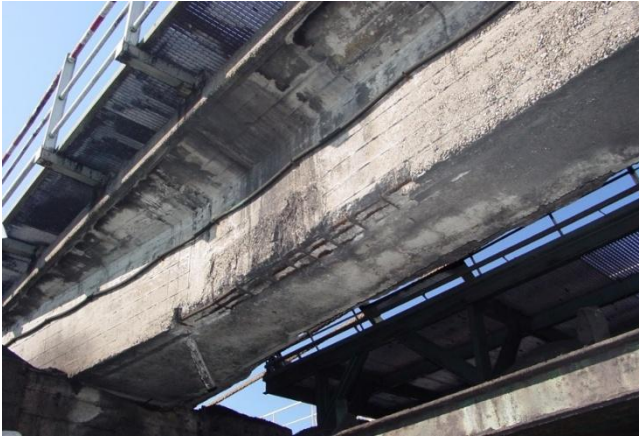
After more than 30 years of service in a harsh marine environment, one of the reinforced concrete pier structures supporting mass loading equipment showed serious signs of structural fatigue. Cracking near supports, delamination of reinforcement cover, and general material degradation led to an urgent decision to carry out repairs and structural strengthening (Fig. 18).

Figure 18. Case study 6, Bottom layer of the beam - visible delamination of the reinforcement cover, exposed reinforcing bars, source: own

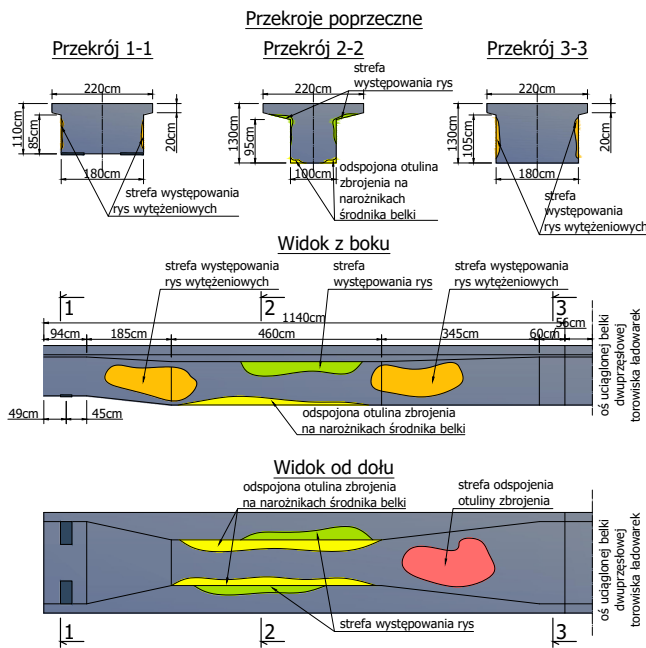
Figure 19. Case study 6, Locations of damage according to preliminary design tests, [48], [49]

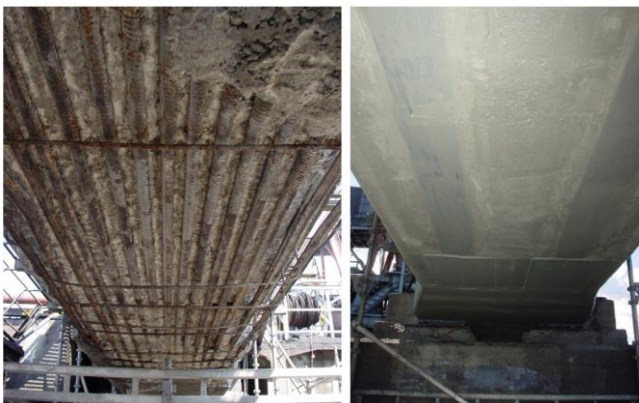
Figure 20. Case study 6, Left: after removal of loose or poorly bonded concrete fragments; all reinforcement bars of the bottom layer are visible. Right: the same element during repair - application and anchoring of carbon fiber tapes, source: own

The chosen solution involved reprofiling the damaged concrete beams and applying external carbon fiber reinforcement. Carbon fiber mats and strips were bonded with epoxy resins to restore load bearing capacity. This method, widely used in structural engineering, offers high tensile strength, corrosion resistance, and allows work to be conducted without heavy equipment. Repairs were performed using suspended scaffolding, with the affected section temporarily closed during works. Other areas of the terminal remained operational. The method proved technologically efficient and economically viable. Thanks to the durability of carbon fiber composites, the reinforced structure is expected to continue functioning reliably for many years (Fig. 19-23).

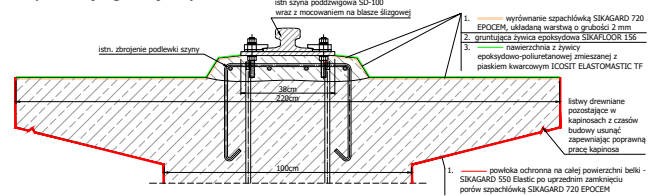
Figure 21. Case study 6, Designed reprofiling and strengthening of crane support beams [49]

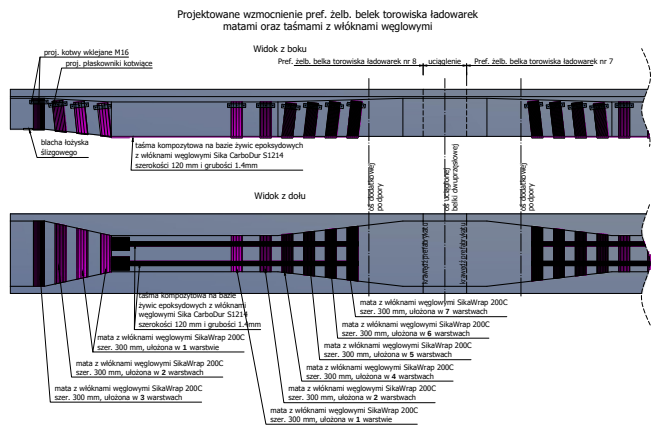
Figure 22. Case study 6, Placing carbon mats and tapes with one prefabricated crane beam [48], [49]

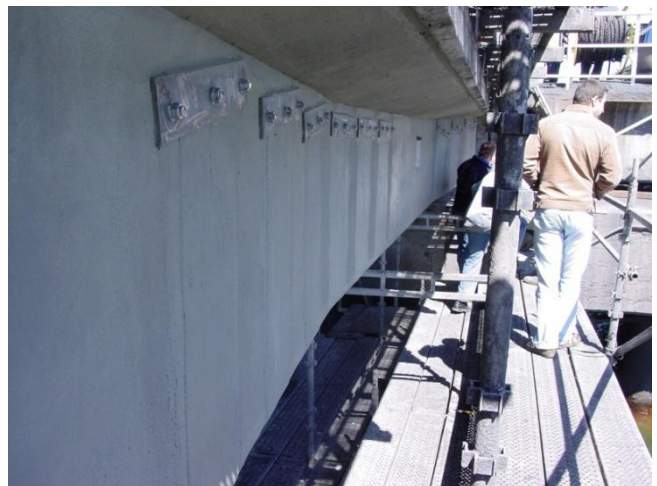
Figure 23. Case study 6, Application and anchoring of carbon fiber mats, source: own
