The Colregs and the Princess Alice

J.F. Kemp

ABSTRACT: There is currently considerable interest in the international regulations for preventing collisions at sea (the Colregs). Suggestions for changes are made, but their validity is difficult to assess because, apart from some very limited simulator experiments, there is no possibility of testing new proposals before they are introduced. Given this situation, it is instructive to look back at past times when the Colregs were somewhat different so that we may, at least, avoid some of the mistakes of the past. In this paper, the author's aim is to look at the lessons that might be learned from one, particularly tragic collision between the *Princess Alice* and the *Bywell Castle* in 1878.

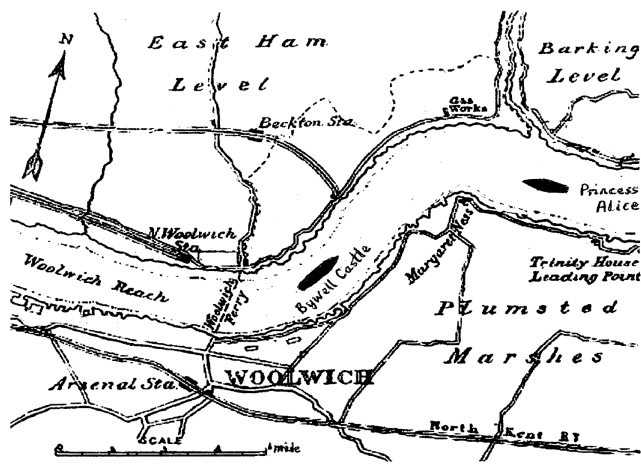
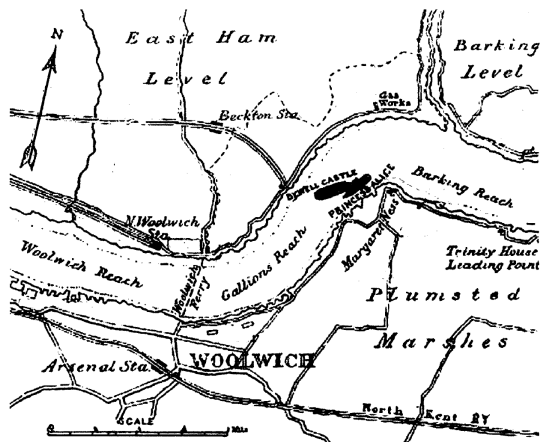
Fig. 1. The positions of the *Princess Alice* and the *Bywell Castle* at 5 minutes before the collision (1A), and at the time of the collision (1B), based on a contemporary chart

At about 1945, Captain Harrison and his pilot, Captain Dix, were on the upper bridge. Their ship was proceeding at half speed down the centre of Gallions Reach. An ebb tide was running, which would have increased the *Bywell Castle*’s speed from 5 knots through the water to about 6 knots over the ground. (See figs 1A and 1B.)

In the event, Captain Harrison saw the red sidelight and white masthead light of the *Princess Alice* when the ships were about a mile apart. This would have been about four minutes before the collision.

Captain Harrison did not have a difficult decision. On seeing the lights of the *Princess Alice*, he altered course to starboard, which took him nearer to the south shore. This measure was in accordance with the suspended rule that ships should keep to the starboard side of narrow channels. It also avoided crossing the bows of the *Princess Alice*. The *Bywell Castle* would, in any case, have soon needed to turn to starboard to negotiate the bend in the river. Finally, since his ship was in ballast, Captain Harrison would not have been unduly worried by the relatively shallow water that tends to accrue on the inside of bends.

At the last minute, when the ships were about 100 metres apart, Captain Harrison saw that collision was imminent, and he gave orders to stop engines and go astern. The order to stop engines was carried out, but collision occurred before the engines were put astern.

At 1945, the *Princess Alice* was in Barking Reach, approaching Tripcock Point (Margaret Ness). She was making 11 knots through the water, which the ebb-tide would have reduced to about 10 knots over the ground. (See figs 1A and 1B.)

It is likely that Captain Grinsted saw the green sidelight and the white masthead light of the *Bywell Castle* at the same time as Captain Harrison saw the lights of the *Princess Alice* – when the ships were about a mile apart. However, Captain Grinsted had a more difficult decision.

He knew that he would soon have to turn to port to negotiate the ninety-degree bend into Gallions Reach. He was probably already on the south side of the river, and would thus have been in a position to save time by keeping to the south side as he rounded the bend. By doing so, the distance would be shorter and the adverse tide would be weaker. Perhaps reciting Thomas Gray's verse to himself he might have had in mind that a green-to-green passing was a safe as a red-to-red passing.

A turn to starboard, on the other hand, would have taken the *Princess Alice* across the bows of the approaching ship, which is something no shipmaster likes to do. Captain Grinsted would have known that the *Bywell Castle* was a large ship because of the height of her green sidelight above the water. He might have expected her to keep to the deep water in the centre of the stream or towards the outside of the bend. He would not have been able to see that, as a ship in ballast, the *Bywell Castle* did not need the deepest water. Finally, he might have worried that, if he altered course to starboard, there might have been insufficient room for the *Princess Alice* to pass between the approaching large ship and the north shore.

In the event, Captain Grinsted chose to alter course to port. A bad move as it turned out, but he had probably made many similar decisions in the past, with perfectly satisfactory results. Whatever the case, the author would not have liked to have been in Captain Grinsted's shoes, and to have faced the dilemma he had to resolve only four minutes before the collision.
