Changes in and Recent Experiences from Norwegian Emergency Towing Service (NETS)

T.E. Berg & Ø. Selvik
SINTEF Ocean, Trondheim, Norway

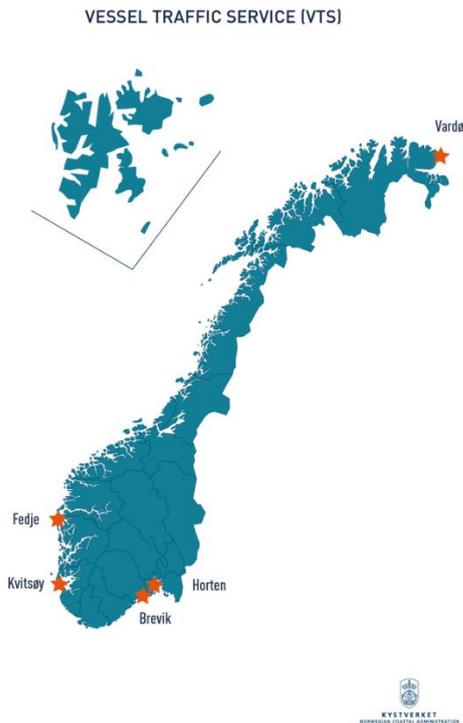
Figure 1. Location of Norwegian Vessel Traffic Centres (Courtesy Norwegian Coastal Administration)

Utilizing NETS experiences, the government decided that commercial companies contracted for NETS duties should be replaced by vessels from the Norwegian Coast Guard (NCG). This change in the organization of the operational part took place from January 1st 2020, when the NCG become the organization operating all vessels in NETS. The reasons behind this reorganization were partly to improve the operational efficiency of governmental vessels and to increase the governmental emergency towing service along the Norwegian coastline. At present, six of the NCG vessels are part of NETS. These vessels can be ordered to prepare for emergency towing activities if some of the vessel traffic centres (VTC) observe a drifting vessel. They could also be requested to take part in other types of rescue missions if requested by governmental or commercial stakeholders. NETS is governed by NOR VTC (located in Vardø, close to the Russian border). This VTC is responsible for surveillance of the outer sailing zones along the Norwegian Coast, where vessels with the highest environmental pollution potential are sailing. The other VTCs (Horten, Brevik, Kvitsøy and Fedje) monitors ship tracks in their respective coastal areas, see figure 1 for location of Norwegian VTC. In emergency situations where there is a need for the NETS, NOR VTC will alert NCG which will allocate vessel(s) for this specific mission.

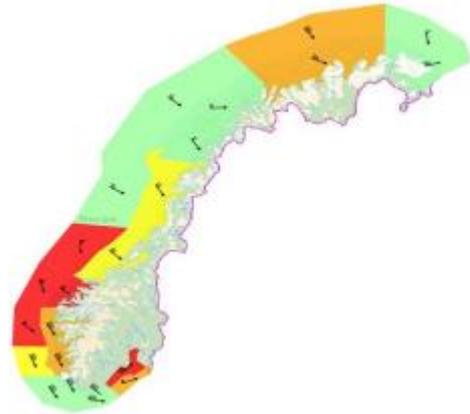
Figure 2. Risk level map for Norwegian coastal areas (Courtesy Norwegian Coastal Administration)

along the coastline. Outcomes are used to develop a map for risk levels related to possible incidents, see figure 2. The colour code used goes from low risk (green) to high risk (red). Risk zones size are primarily computed based on forecasted onshore wind (speed and direction). This map is used by NOR VTC to recommend locations for vessels in NETS on a daily basis. Two of the cases discussed in section 5, happened in the western red zone.

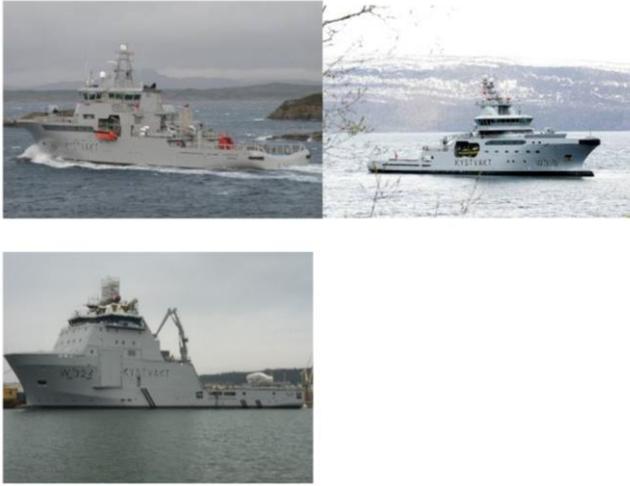
Figure 3. Vessel types in the NETS (upper left KV Harstad, upper right Barents class vessel and lower left new anchor handling tug) – (Photos Norwegian Coast Guard)

At present there are six vessels in NETS. Four of the vessels are ordinary Norwegian Coast Guard vessels, while two last two are hired offshore vessels. NCA requires at least a Bollard Pull of 100 tons for vessels in NETS. Table 1 lists the bollard pull of the vessels operated by NCG. The last two vessels in Table 1 are anchor handling tugs, on a five-years lease contract with Boa Offshore. They will be manned by Coast Guard personnel after a transition period of a couple of years. Part of the personnel will be transferred from existing Coast Guard vessels. Based on positive operational experience, the contract for the Boa Offshore vessels may be renewed for another five-years period. Figure 3 presents the different types of vessels allocated for NETS operations by NCG.

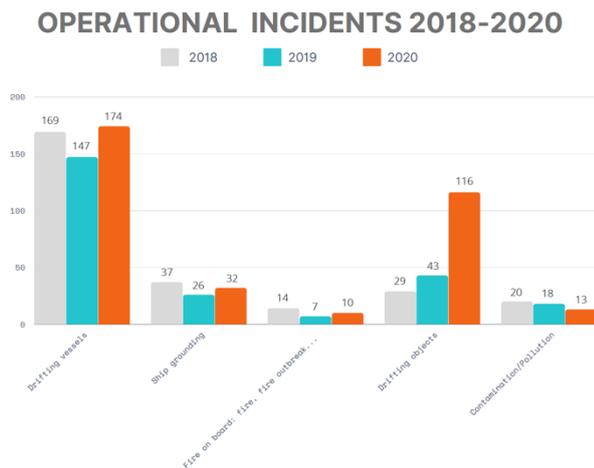
Figure 4 Incidents in Norwegian waters 2018 – 2020. (Based upon data from NCA)

NOR VTS collects information on different types of incidents and accidents within the Norwegian coastal waters. In a previous paper [1], data on drifting vessels for the period 2011 – 2018 was presented. Figure 4 presents new data compiled by the Analytic Group of NCA. The number of drifting vessels was smaller in 2019 than 2018 and 2020. But some of the 2019 cases involved major SAR operations to rescue crew (fishing vessel "Northguider" in Hinlopen, northern part of the Svalbard archipelago) and passengers (Cruise vessel "Viking Sky", at Hustadvika) [2].

From figure 4 it should be noted that there has been a large increase in drifting objects. Part of this increase comes from loss of containers from container

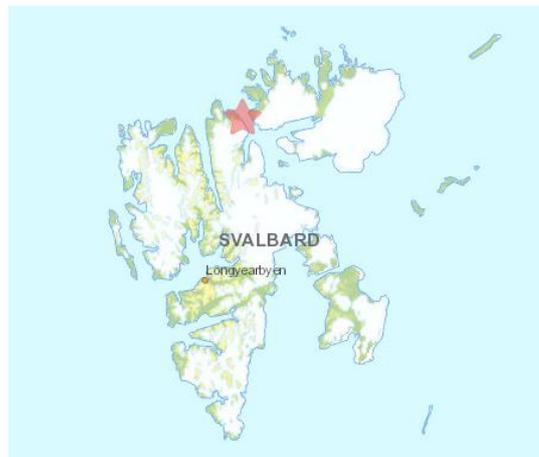
Figure 5. Accident site for "FV Northguider"

The vessel was fishing north of Svalbard, when in Arctic utter darkness it ran aground in the Hinlopen Strait (see figure 5), grounding at Kinnvika in Nordaustlandet, which is a national park. The vessel was flooding and had a heavy list. The Joint Rescue Coordination Centre in Bodø received an emergency call from the master of "FV Northguider". The SAR resources of the Governor of Svalbard were mobilised and two helicopters took off from Longyearbyen. Just two hours after the emergency call, the first ten crew members were rescued and returned to Longyearbyen. One hour later the second helicopter rescued the remaining four crew members. The airborne capacity of the helicopters was fully used in this operation (airborne time remaining at the end of the operation was less than 10 minutes).

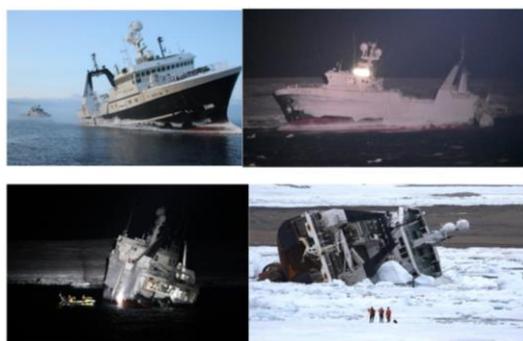
Figure 6. Different phases prior to the final "FV Northguider" wreck removal – grounded vessel – initial icing - inspection of wreck (Photo: NCA) work in Hinlopen 2020 (Photos: NCA, NCG – KV Svalbard and Governor of Svalbard)

But because it was in a protected area, the Svalbard Environmental Protection Act mandated the ship's owner to remove the vessel. Smit Salvage was awarded the removal contract, and initiated work to run the operation during the 2019 summer season. Due to local ice and weather conditions, the operation was aborted. Some snapshots showing the faith of the vessel are collected in figure 6.

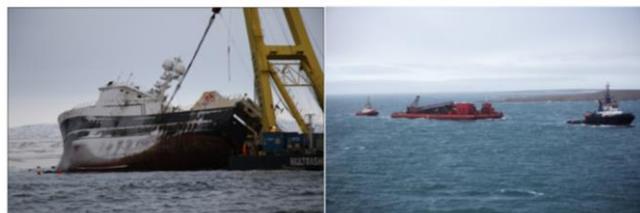
Figure 7. Salvage of "Northguider" – preparing for dismantling and towing of wreck parts (Photo: Governor of Svalbard, NCA)

The operation was restarted in late July 2020, being successfully completed in September 2020. Two barges, their tugs, anchor handling vessels, and vessels able to keep small ice fragments away from the work area were mobilized for the wreck removal. The wreck was cut into fifty small pieces which were lifted onto the barges and towed back to mainland Norway, see figure 7 During the salvage operation, the former Norwegian research ship "Lance" participated as a base for NCA personnel overseeing the operation. This wreck operation was challenging as it took place at 80° north in an area far from normal logistics support services.

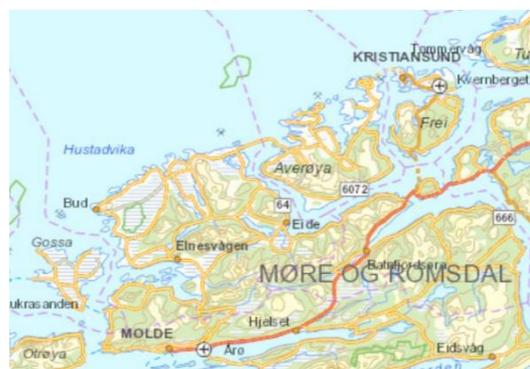
Figure 8 The Hustadvika area – an exposed sailing area between the Norwegian cities Kristiansund and Molde. Source: Kystinfo (kystverket.no)

The cruise vessel "Viking Sky" was steaming southbound from a Northern Norway cruise late March 2019. Passing the Hustadvika area (figure 8) in stormy weather (wind speeds of 22 – 25 m/s and waves at up to 15 m), the vessel experienced an engine shutdown. The situation quickly got serious due to the uncontrolled motions of the vessel and a drifting motion that would lead to a grounding. The metocean forecasts mean that other traffic in the area was already, to a large degree, cancelled. Such was the case for the coastal express vessels operated by the Hurtigruten company.

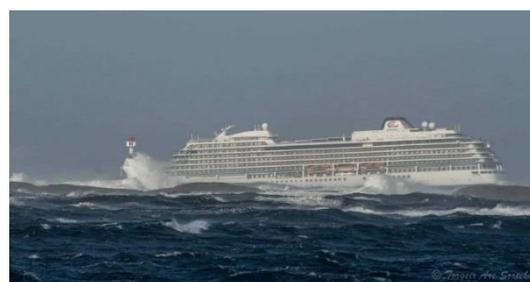
Figure 9. Cruise vessel "Viking Sky" - drifting case at Hustadvika, March 2019 (Photo: Torgeir Are Sortehaug)

resulted in a drifting speed up to 9 knots for "Viking Sky". To prevent grounding, the vessel dropped two anchors. Initially they just dragged along the sea bottom and reduced the drifting speed somewhat. At 3.40 pm the ship crew was able to restart one of the four engines. This, together with the drag of the anchors, stopped the vessel's drifting motion and prevented a possible grounding, see figure 9. At that time, the primary goal of the JRCC and NCA was to tow the vessel out from the coastline. Due to the weather conditions and position of the vessel, it was evaluated that the risk related to prepare for an emergency towing operation was too high under the prevailing weather conditions. The NCG vessel "KV Njord" arrived early at the incident site and was appointed "On-Scene Commander" at 5 pm. Contacts with other vessels in the area and the pilots on board "Viking Sky" were their main responsibility, as initially there were no plans for emergency towing or the evacuation of the vessel. Shortly afterwards, four offshore vessels and a tug arrived at the incident site, followed later by the NETS tug "Boa Heimdal", which arrived and was told to stand by until it was safe to fasten emergency towing lines.

The ship then kept position approximately 100 m from the coastline and only a few meters from a reef. Vessel motions were significant due to the high waves. Excessive combined heave, pitch and roll motions resulted in injuries to passengers. The waves entered the lower open deck and water started to flow into the ship, with some passengers, especially older people, suffering fear. In collaboration with the "Viking Sky" master, the JRCC Southern Norway decided to start an evacuation procedure (the total number of passengers and crew was 1363). Governmental SAR helicopters were scrambled and one commercial SAR helicopter (with operation base

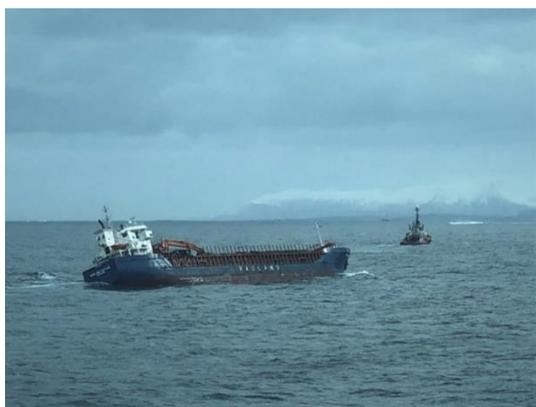
Figure 10. "Boa Balder" towing "Hagland Captain" to port. (Photo: NCG)

While rescuing "Viking Sky" passengers, JRCC Southern Norway received another mayday call from a small cargo vessel, the "Hagland Captain", also sailing in the Hustadvika area. This vessel had another engine blackout. The ship dropped both anchors, which dragged for some time before they took hold some 50 m from an underwater reef. It was decided to evacuate the vessel, due to lack of control and a significant list. The crew were instructed to jump into the sea and were picked up by one of the SAR helicopters taking part in the "Viking Sky" operation. The NETS vessel "Boa Heimdal" was released from duties related to the "Viking Sky" operations and given orders to observe the development. As the ship crew was evacuated, it was not possible to establish an emergency towing connection under the actual weather conditions. As the weather condition improved, a commercial tug was awarded a contract for towing "Hagland Captain" to port, see figure 10.

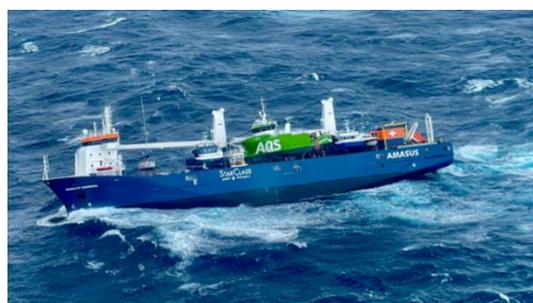
Figure 11. "Emslift Hendrika" – early stage of drifting west of Stadt (Photo: CHC Helikopterservice/ JRCC Southern Norway).

The vessel was on route from Bremerhafen to Kolvereid in Mid Norway. In rough weather "Emslift Hendrika" had a shift of cargo, followed by an engine blackout in the North Sea west of Stadt on the Norwegian west coast on April 5th. As a result, the vessel started drifting, and reach a significant list

under large ship motions. It was decided to evacuate the ship, see figure 11. First, eight of the crew members were rescued using a Norwegian SAR helicopter. Four crew members stayed on board to try to stabilize the rolling motion and to prepare for the connection of emergency towing lines before they rescued by the helicopter. All crew members had to jump overboard to be picked up. The drifting path was followed closely by NOR VTS using their prediction tool for drifting of ships. From AIS signals NOR VTS could follow the actual drift motions. The NETS vessel "KV Sortland" was on-scene to observe and forward information to NCA. At 6 pm the following day, the vessel was unmanned and drifting 40 – 50 nautical miles west of Ålesund. Figure 12 is a map showing the actual drift track and predictions of future drift path. Weather conditions remained harsh, with waves of up to 15-18 m being observed, wind of 18 – 20 m/s coming from the north, which made it impossible to get specialists onboard the drifting vessel. It was observed that part of the deck cargo, a 24 m aquaculture service vessel, was lost to the sea. One of the deck cranes was also damaged.

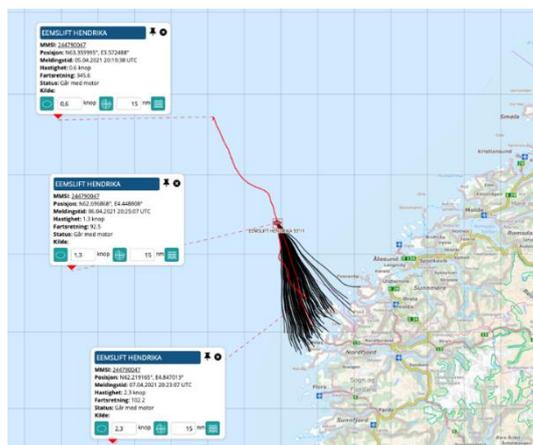
Figure 12. Observed and predicted drifting path for "Emslift Hendrika" (Courtesy NCA)

Operational experience from the "Eemslift Hendrika" case shows that there still is a need to improve tools for prediction of ship's drift and training of operators using such tools for different types of vessels and in an ongoing salvage operation.

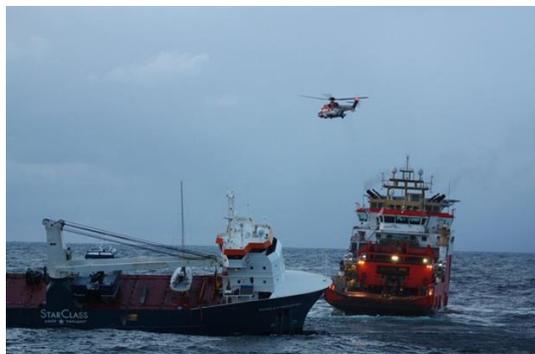
Figure 13. Preparing for emergency towing of "Eemslift Hendrika" (Photo: Norwegian Coast Guard – "KV Bergen")

protection resources in the area and prepared for a NETS operation. A SAR helicopter was allocated to attempt to bring Smit Salvage specialists to the drifting vessel. This operation was successful, and the salvage crew prepared equipment for emergency towing, both at bow and stern. Two commercial tugs ("Normann Drot" and "BB Ocean") were able to connect, and the emergency towing started, see figure 13.
