# Modern Navigation Challenges – Case Study Based on Students' Practices on r/v Horyzont II in the Gulf of Gdańsk

A. Kerbrat & J. Pietraszkiewicz  
*Gdynia Maritime University, Gdynia, Poland*

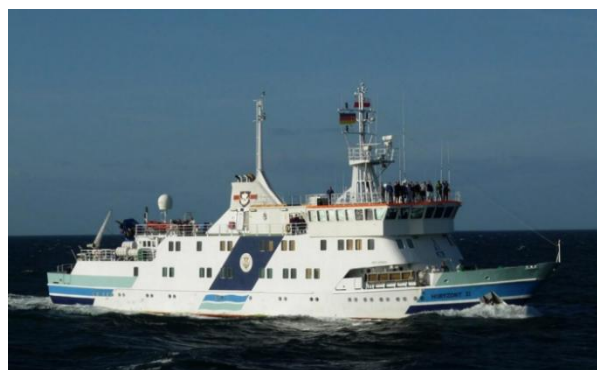
Figure 1. Research vessel "Horyzont II".

conditions vary and may include light icing, fog, stormy with a lot of precipitation. Its specific construction, based on "Polarex" plans, gives the ship unique manoeuvring properties. In Figure 1, a general overview of the RV "Horyzont II" is shown. Visible are the features of the hull, such as a high freeboard and a navigational bridge located in the forward part of the vessel. The ship is equipped with a bow thruster and a pitch propeller improving manoeuvrability.

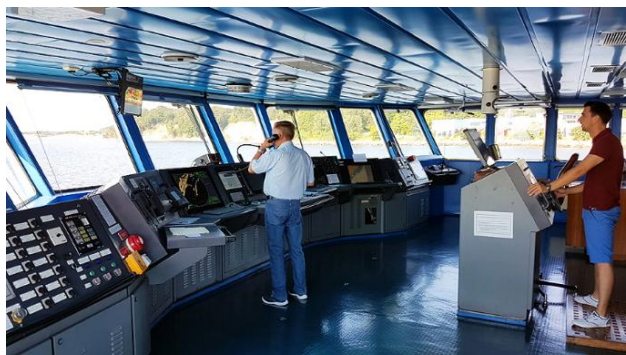
Figure 2. Navigational Bridge of the research vessel "Horyzont II".

The navigational bridge of "Horyzont II" has been adapted to support training activities. Besides all regulatory equipment demanded by SOLAS it is equipped with additional navigational equipment available to students. In Figure 2 the general arrangement of the bridge is visible, out of the picture are four students' navigational tables. Two of them are equipped with two Furuno X-band radar displays operating in a master-slave configuration. They use an antenna separate from the two main ships' radars. This allows students to use them freely without interrupting the safety of navigation or the general work of navigating officers. At these two stations, two independent GPS receivers are also available (JRC and Furuno). The third station is equipped with a repeater of the electronic chart (ECDIS) station NaviSailor 4000. Functions that cannot be accessed in there can be used by students on the master station under the supervision of the duty officer. It is worth mentioning that the "Horyzont II" ECDIS serves as an aid to navigation, and the ship is required to carry paper charts as the primary means of navigation. The fourth workstation is dedicated to paper charts navigation and performing all other required actions, such as making corrections to paper charts and completing the necessary logbooks.

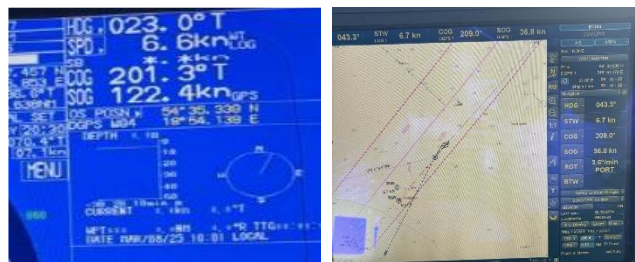
Figure 4a & b. Radar image (a) and ECDIS display (b) recorded on 8 of March 2025 during GPS signal disruption.

Around 10.00 AM local time, the first anomalies in the GPS data were observed. At that moment, "Horyzont II" was passing "GD" (54°32,1'N 018°39,8'E) on port side buoy located at the junction of TSS. The attention of the instructor and OOW was drawn to a significant discrepancy between the vessel's water-referenced vector (log speed and heading) and the ground-referenced vector provided by GPS. These discrepancies were recorded and are presented in Figures 4a and 4b. As visible, the data received from the ship's log were significantly different from the data received from the GPS.

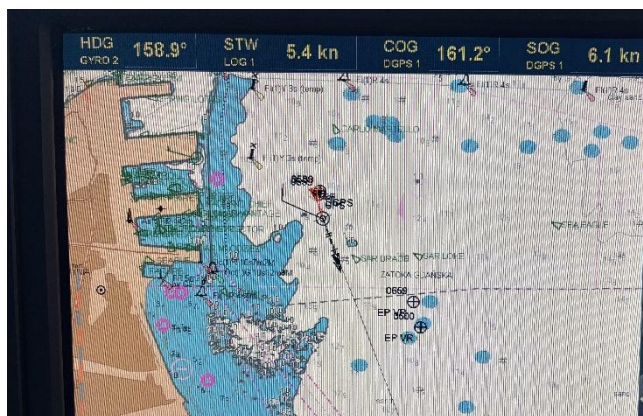
Figure 8. Positions marked by students in ECDIS while at anchor with a properly working GPS.

Figure 8 presents a comparison between positions obtained from the GPS system (upper section of the display) and those plotted by students based on radar measurements (lower section). The discrepancy between these two sets of positions was significant and exceeded the expected measurement uncertainty associated with radar fixes and manual plotting.

A post-watch analysis revealed that the students responsible for determining the radar-derived positions committed procedural errors. These errors concerned two principal aspects:

1. Incorrect transfer of radar data into the ECDIS system — in several cases, distances and bearings to radar targets were entered with rounding errors or incorrect values, resulting in a shifted plotted position.
2. Improper use of ECDIS plotting tools — instances were identified in which students incorrectly determined the intersection point of lines of position or failed to apply the standard procedure for verifying consistency with the previous fix.

As a result, the radar-based positions deviated from the true vessel position in a systematic rather than random manner, indicating a methodological error rather than any technical limitation of the radar.
